GM8428

2015-16 DURAMAX 6.6L DOWN PIPE 3-BOLT FLANGE

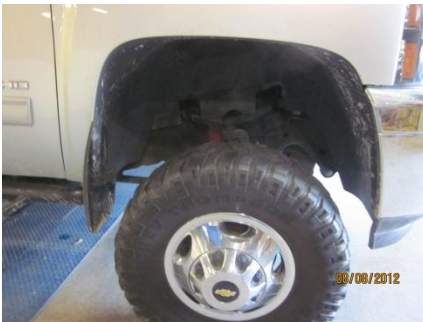
Figure 1

1. Remove the passenger-side inner fender.
See Figure 1.
Note: we also removed the Grille Assembly to prevent damage to it during the removal or installation of the down pipe.
2. The front pipe needs to be temporarily removed. Carefully disconnect all sensors and loosen the four flange nuts on the rearward part of the front pipe. The transmission cross-member will need to be temporarily dropped to remove the front pipe. Remember to support the transmission with a block or jack stand while doing the transmission cross-member removal.
See Figure 2.
3. Remove the hex bolt securing the down pipe to the exhaust manifold. Remove the sensor located just above the hex bolt. The 3 nuts connecting the front pipe to the down pipe can also be removed. Save the hex bolt, nuts and sensor for the installation.
See Figure 3.

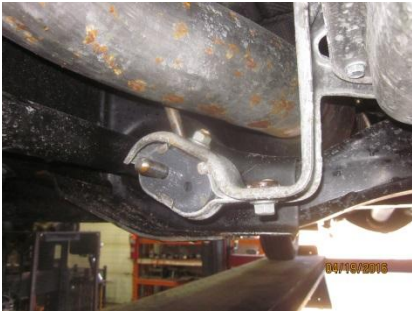
Figure 4

4. The front pipe has a hanger mounted to the transmission that will also have to be removed. Remove the bracket from the transmission.
See Figure 4.
5. Remove the combination stud/bolt from the transmission bellhousing just above the locating dowel. It has already been removed in **Figure 5**. This is to allow the clearance necessary to remove the down pipe.

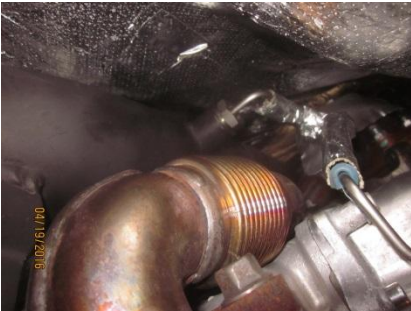
Figure 8

4. Install the stock sensors into the **Down Pipe**. One is located along the lower section of the **Down Pipe (Refer to Figure 8.)** The other two sensors are located closer to the turbo.

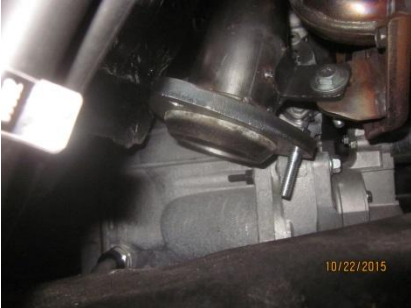
Figure 9

5. The front pipe can then be reinstalled using the supplied **3/8" Bolts, Flat Washers, Lock Washers and Nuts**; as well as the factory hardware for the 4-bolt flange.
See Figure 9.

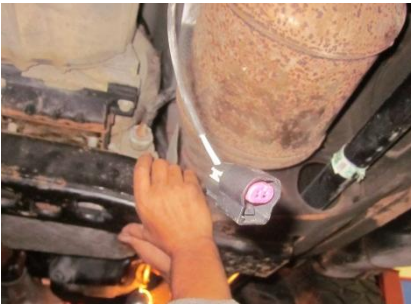
Figure 10

6. Reinstall the transmission cross-member. Reinstall the exhaust hanger to the transmission. Reconnect all the sensors to the front pipe.
See Figure 10.
