GMCA428

2015-16 DURAMAX 6.6L DOWN PIPE 3-BOLT FLANGE

MBRP

50 STATE LEGAL
CARB E.O. # D-763-2

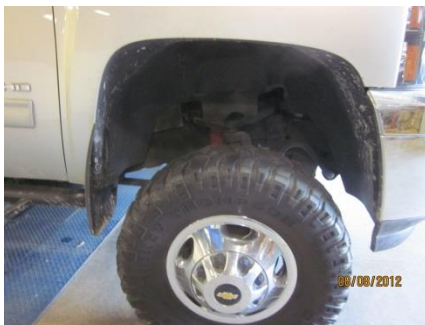
Figure 1

1. Remove the passenger-side inner fender.
See Figure 1.
Note: we also removed the Grille Assembly to prevent damage to it during the removal or installation of the down pipe.
2. The front pipe needs to be temporarily removed. Carefully disconnect all sensors and loosen the four flange nuts on the rearward part of the front pipe. The transmission cross-member will need to be temporarily dropped to remove the front pipe. Remember to support the transmission with a block or jack stand while doing the transmission cross-member removal.
See Figure 2.
3. Remove the hex bolt securing the down pipe to the exhaust manifold. Remove the sensor located just above the hex bolt. The 3 nuts connecting the front pipe to the down pipe can also be removed. Save the hex bolt, nuts and sensor for the installation.
See Figure 3.

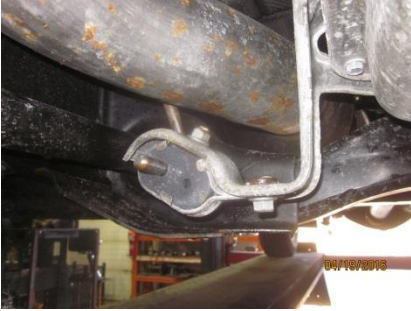
Figure 4

4. The front pipe has a hanger mounted to the transmission that will also have to be removed. Remove the bracket from the transmission. **See Figure 4.**

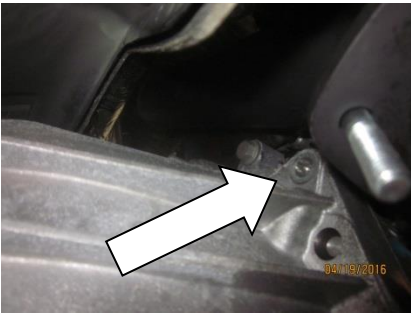
Figure 5

5. Remove the combination stud/bolt from the transmission bellhousing just above the locating dowel. It has already been removed in **Figure 5**. This is to allow the clearance necessary to remove the down pipe.

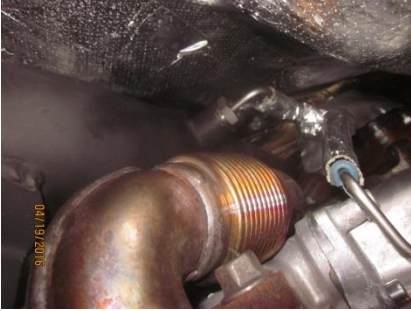
Figure 8

4. Install the stock sensors into the **Down Pipe**. One is located along the lower section of the **Down Pipe** (Refer to **Figure 8**.) The other two sensors are located closer to the turbo.

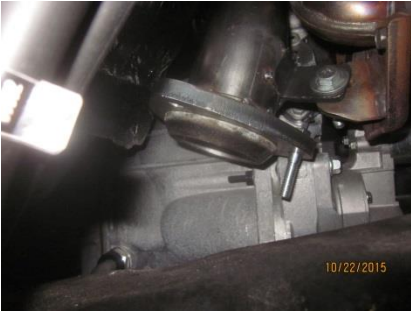
Figure 9

5. The front pipe can then be reinstalled using the supplied **3/8" Bolts, Flat Washers, Lock Washers and Nuts**; as well as the factory hardware for the 4-bolt flange. **See Figure 9.**

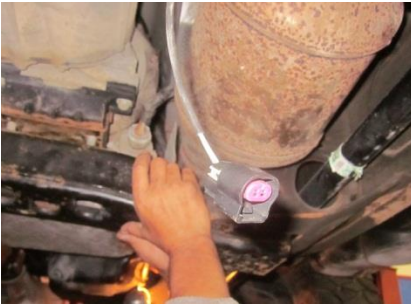
Figure 10

6. Reinstall the transmission cross-member. Reinstall the exhaust hanger to the transmission. Reconnect all the sensors to the front pipe. **See Figure 10.**

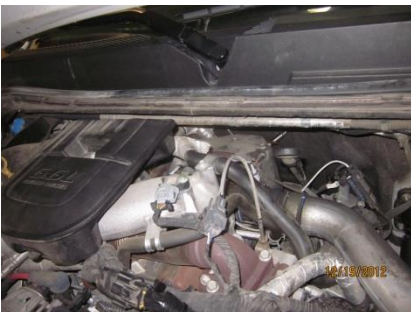
Figure 11

7. Reinstall the passenger-side inner fender.
8. Reinstall the turbo heat shield. Check along the exhaust and make sure all connections are tightened. Check along the whole length of the exhaust system to ensure that there is adequate clearance around the spare tire, fuel and brake lines or any wiring. If there is any interference detected relocate or adjust. **See Figure 11.**
